INEEL/EXT-03-01126  
August 2003

# 2003 Annual Inspection Summary for the Stationary Low-Power Reactor-1 Burial Ground

Operable Unit 5-05

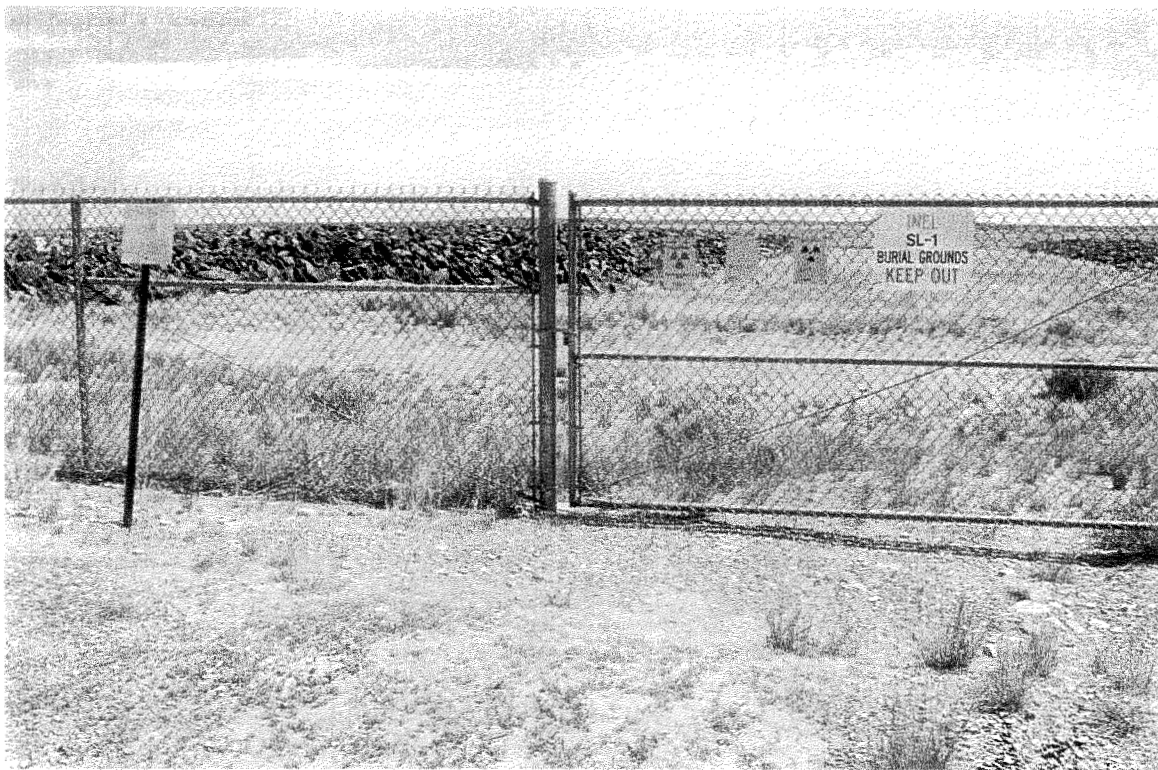
4. Rad survey.	<i>John R. Giles</i>	03-Jun-2003	
<b>INSTITUTIONAL CONTROLS</b>			
1. Document that fences restrict access.	<i>John R. Giles</i>	03-Jun-2003	All fencing and postings are in place and intact. There are four marble monuments with brass cap markers around the perimeter of the fence. The CERCLA sign needs to be updated with the WCC phone number (526-1515) for contact information.

Attachment 2, Figure 1. ARA-06, SL-1 Burial Ground access gate with radiological control postings and CERCLA sign (Picture PD030195-01).

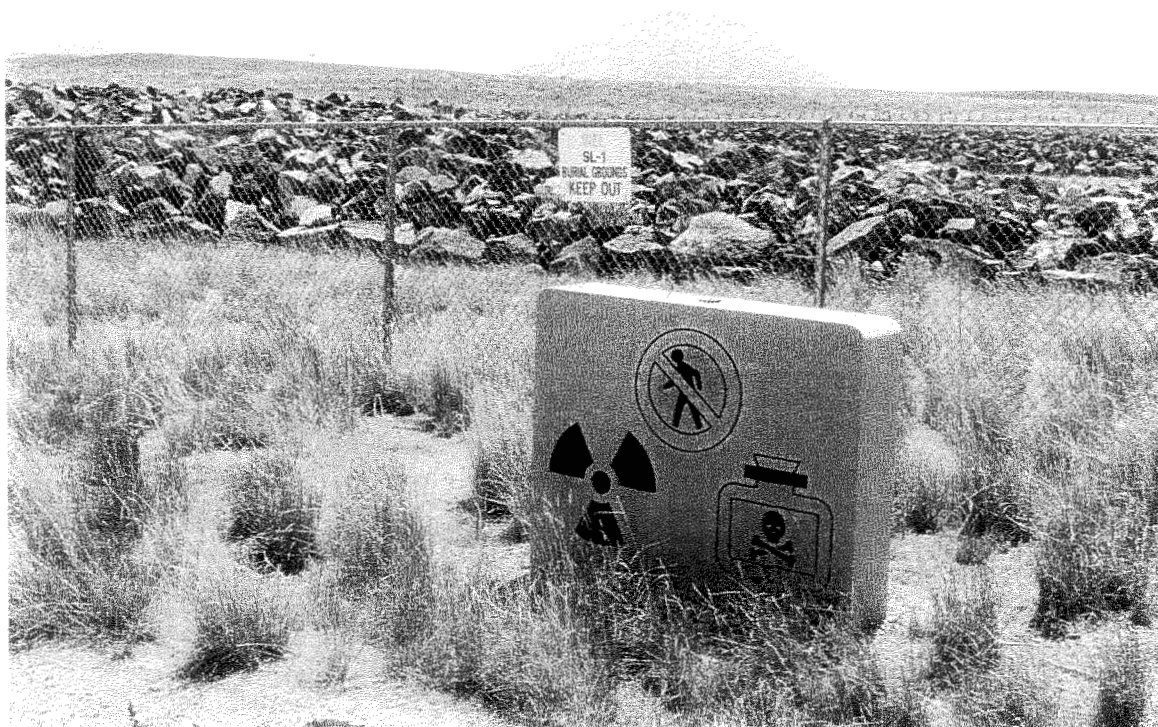
Attachment 2, Figure 2. ARA-06, SL-1 Burial Ground monument with burial ground cap and fence enclosure in background (Picture PD030195-06).

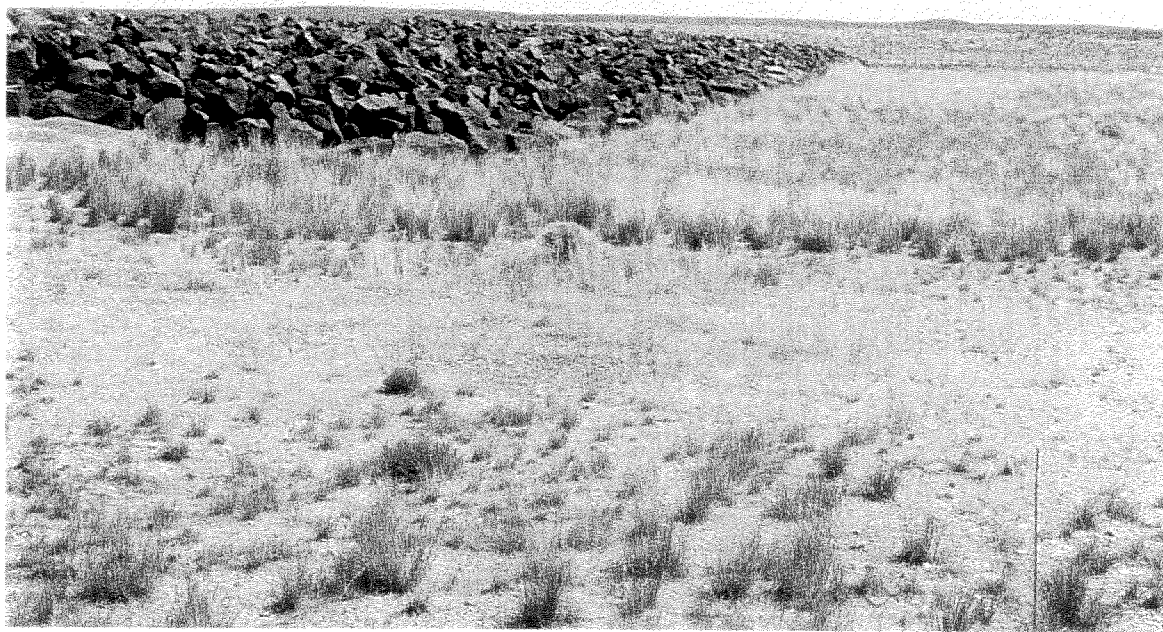
Attachment 2, Figure 3. ARA-06, human intrusion barrier covering Trench 1 and Pit 2 (Picture PD030195-03).

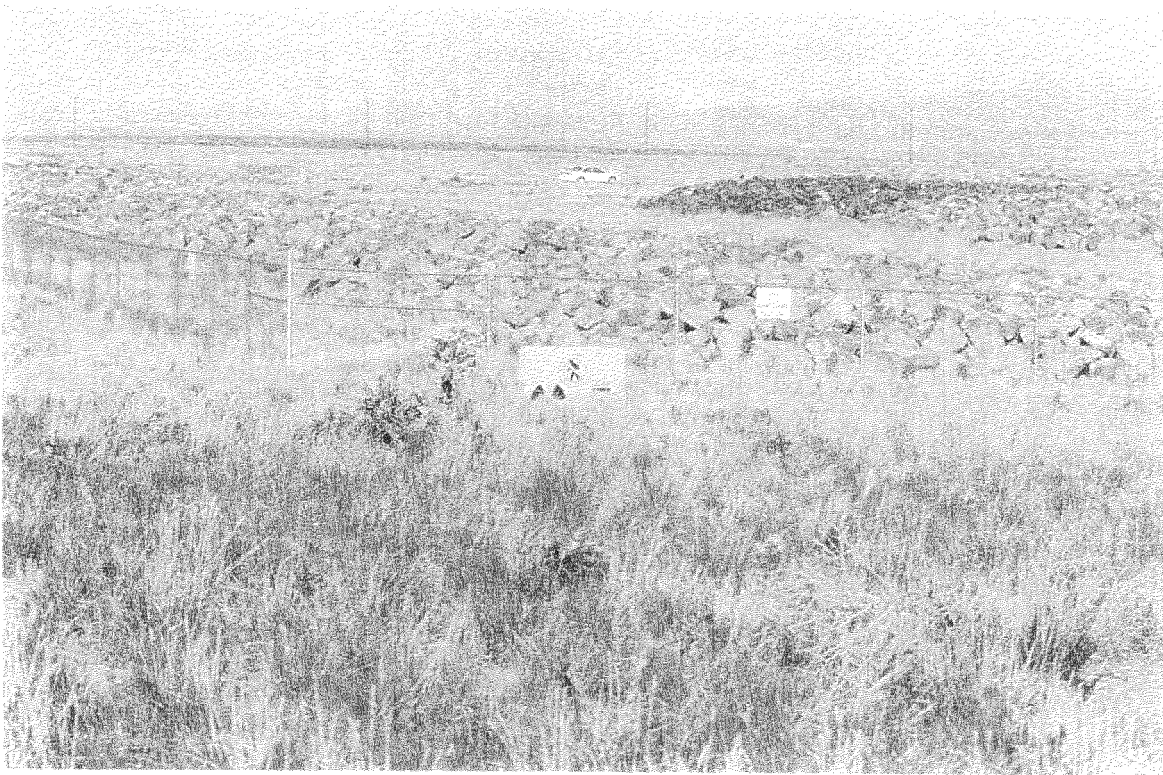
Attachment 2, Figure 4. ARA-06, human intrusion barrier covering Pit 1 (Picture PD030195-08).

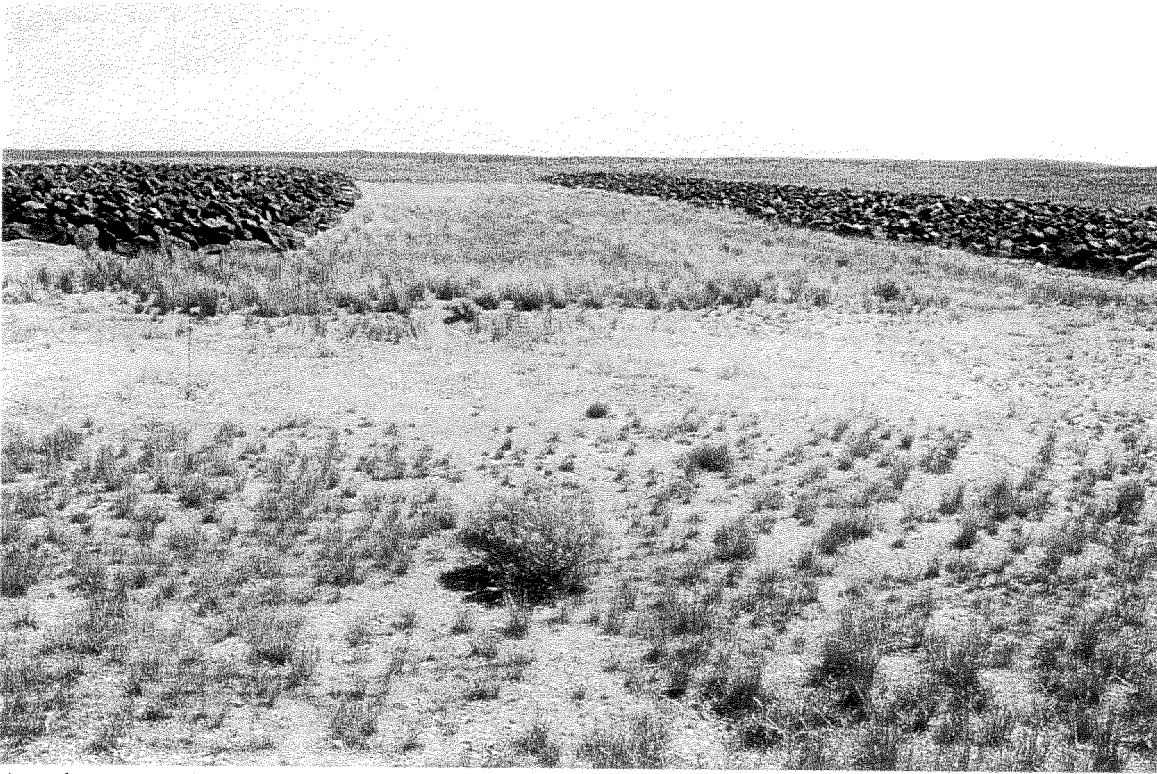
INSPECTION ACTIVITY	INSPECTOR SIGNATURE	INSP. DATE	COMMENTS/RECOMMENDED REPAIR
<b>REVEGETATED AREAS</b>			
1. Inspect for non growth areas	<i>John R. Giles</i>	03-Jun-2003	Vegetation is well established around the perimeters of the rip rap covers and around the perimeter of the SL-1 burial ground fence. Some rabbit brush observed inside the fence.

Attachment 2, Figure 5. ARA-06, SL-1 Burial Ground vegetation inside the fence  
(Picture PD030195-04).

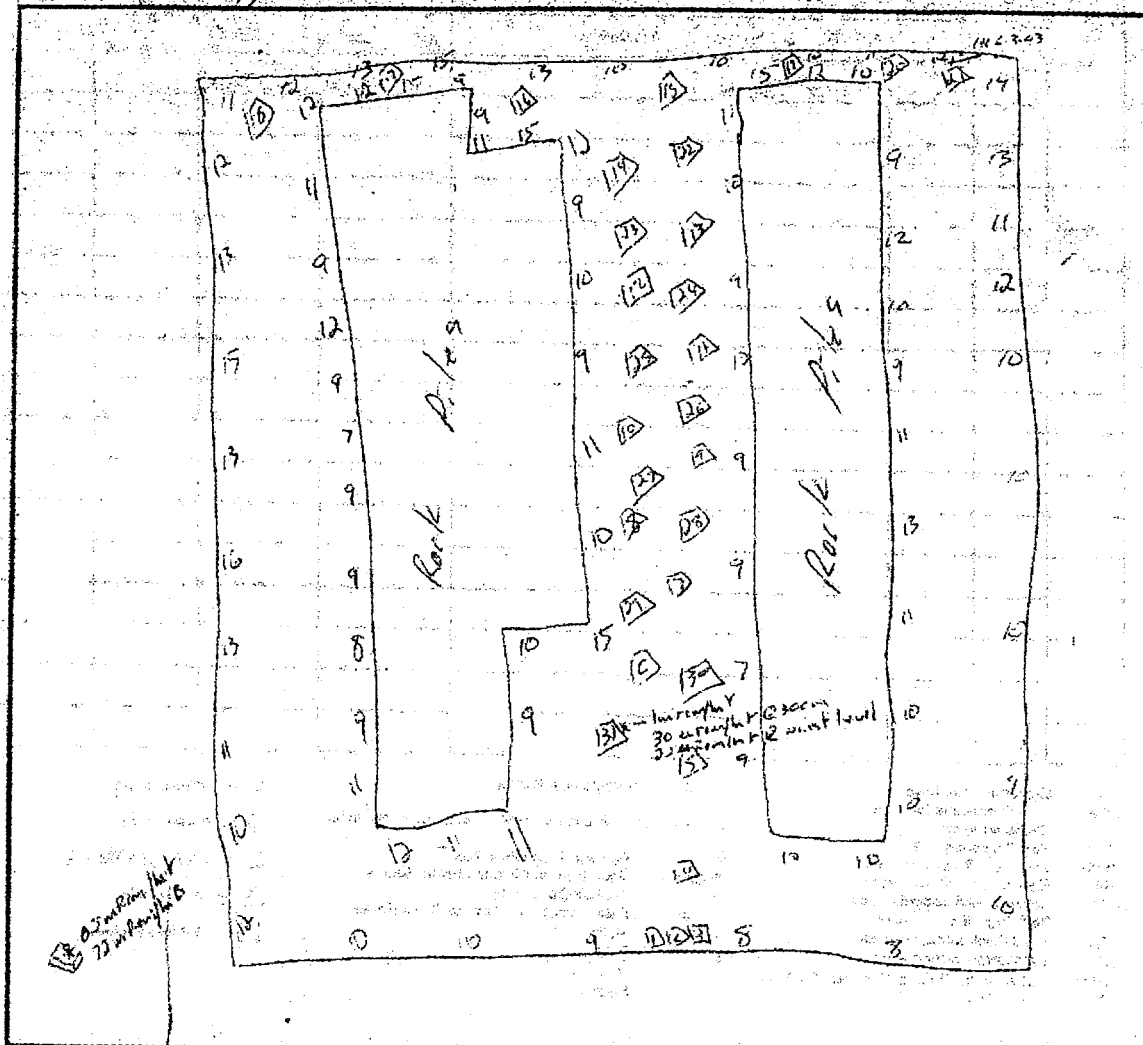
Radiological surveys were conducted around the perimeters of the engineered covers at the SL-1 site. A radiological control technician performed the surveys on June 3, 2003, with a micro-Rem ( $\mu\text{R}$ ) survey meter. The results of those surveys are shown in Attachment 3. The surveys were performed around the perimeters of the SL-1 covers and the fence, using the hand-held instrumentation at waist height. The dose rates at the SL-1 site ranged from 7 to 20  $\mu\text{R/hr}$ . These exposure rates are consistent with past survey results, which have ranged from 7 to 35  $\mu\text{R/hr}$  at SL-1.
